# Dye Tracer Tests in Karst

- *Nicholas C. Crawford, Ph.D., P.G.*

Center for Cave and Karst Studies  
Applied Research and Technology Program of Distinction  
Department of Geography and Geology  
Western Kentucky University  
Bowling Green, KY 42101

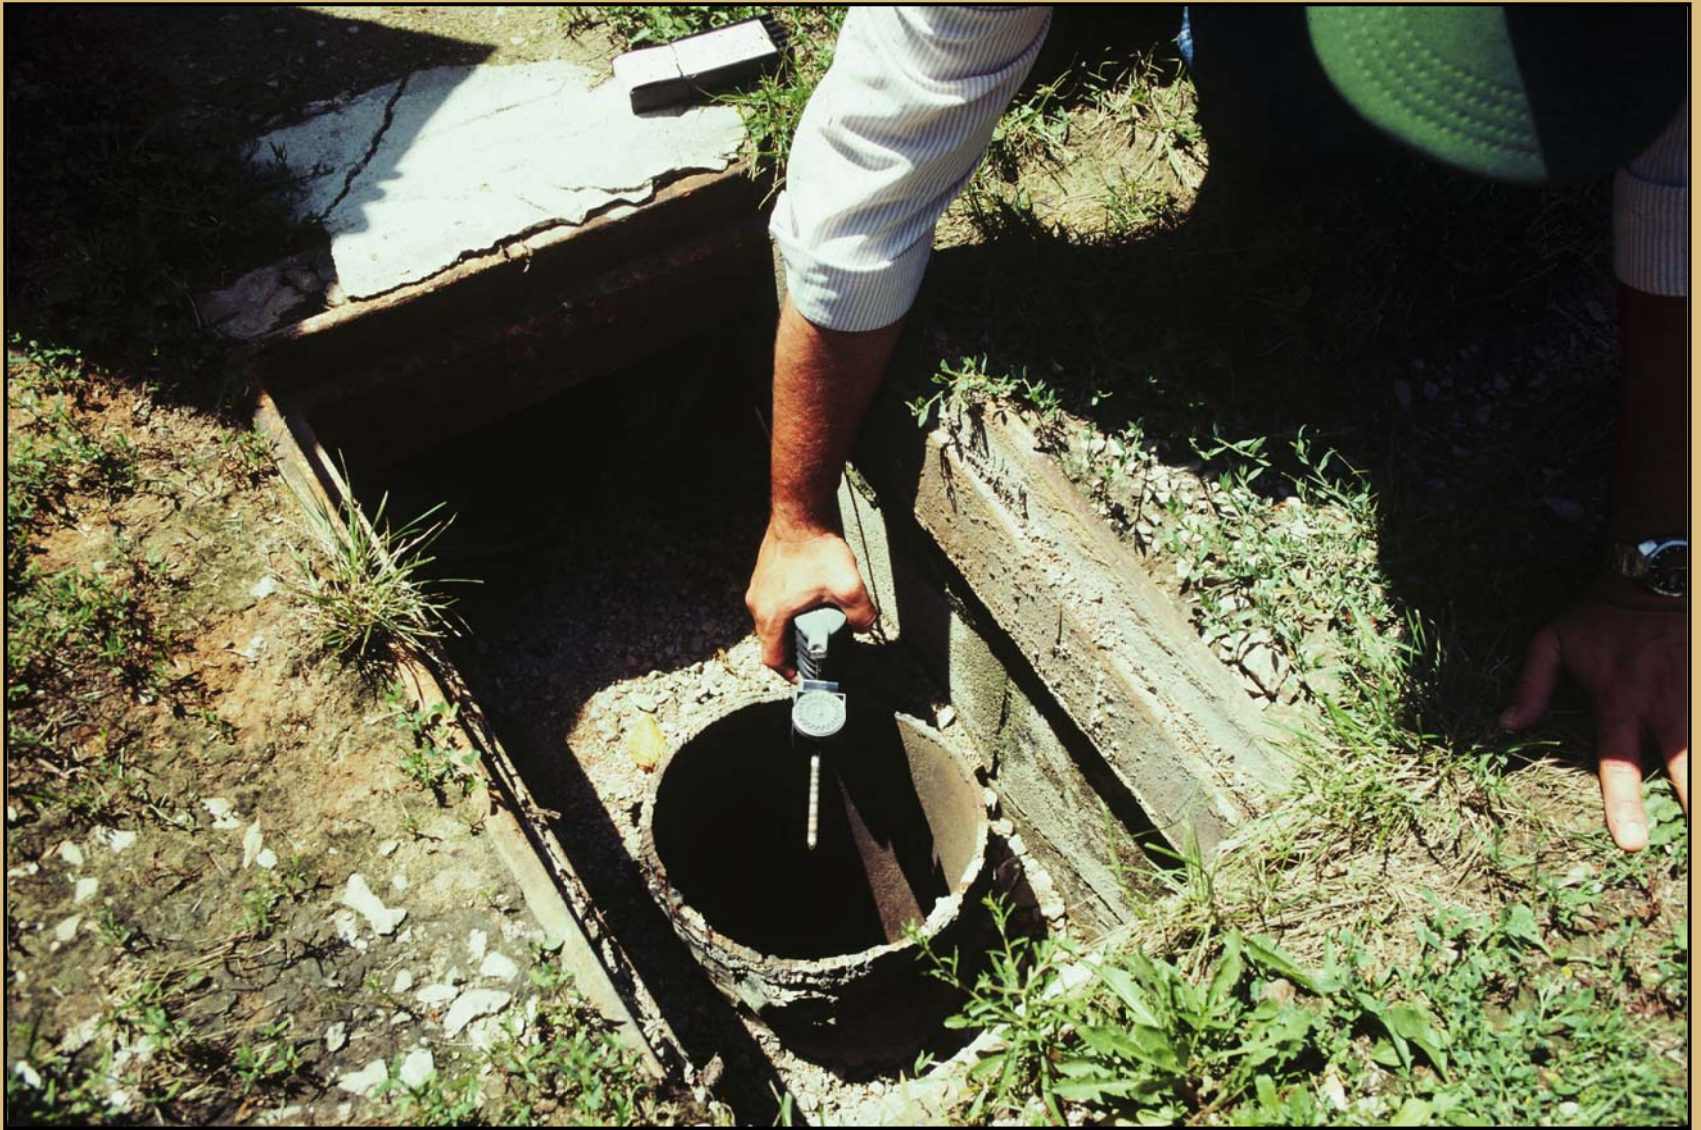
Toxic and explosive vapors rising from storm water drainage well.  
USEPA Superfund emergency Bowling Green, 1985-1986

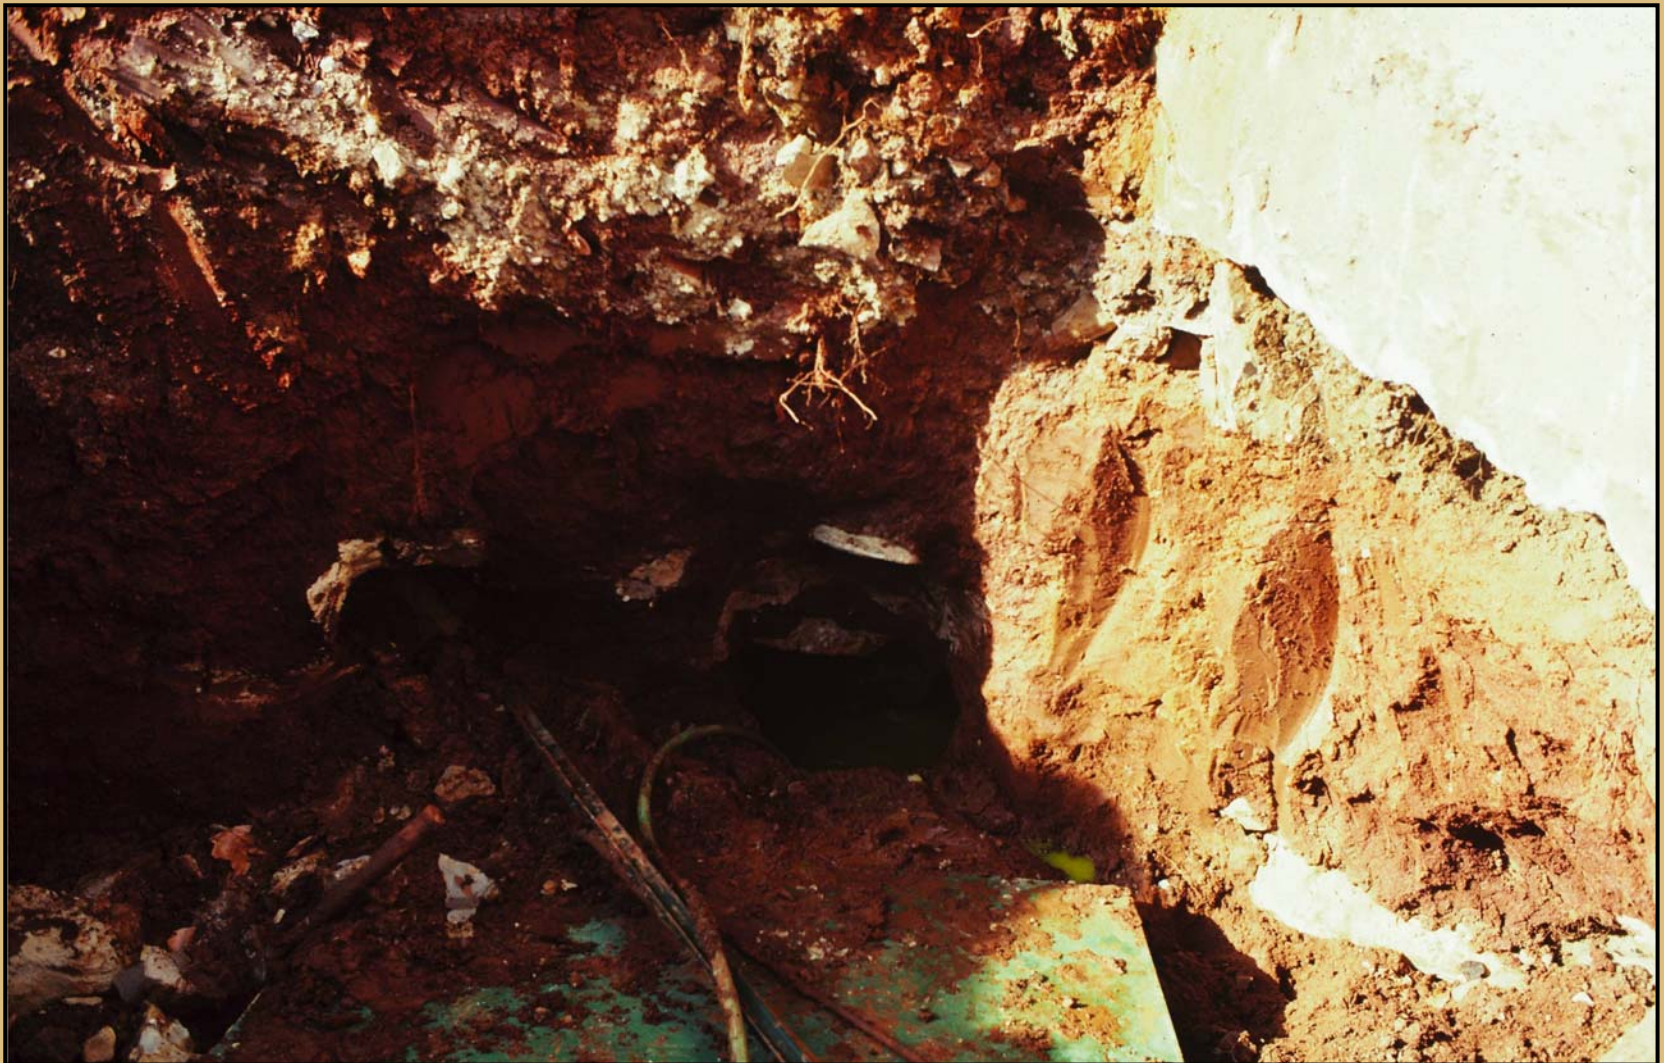
Toxic and explosive vapors rise into Parker Bennett Elementary School in Bowling Green, Kentucky on Thanksgiving weekend in 1985. Excavation to bedrock revealed that the vapors were rising from a bedrock crevice.

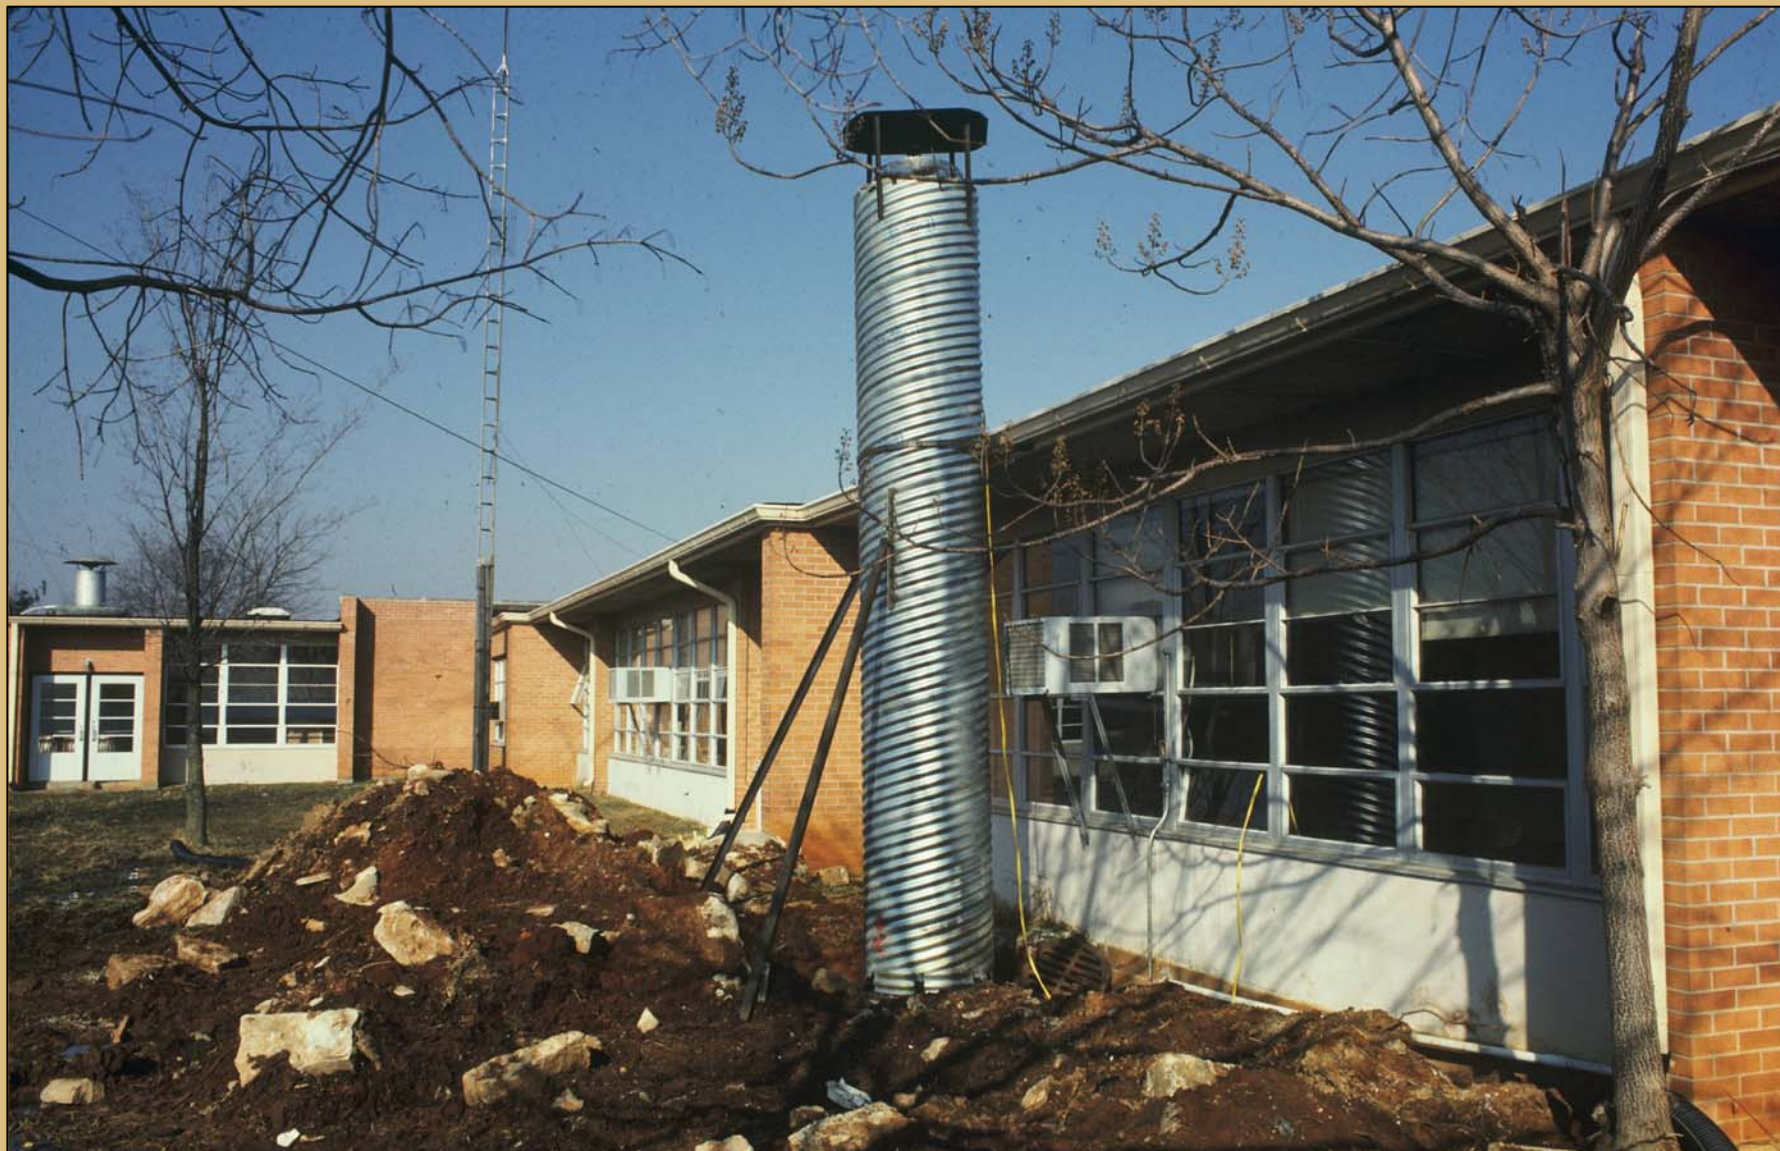
Pipe with large explosive proof fan used to vent vapors into the atmosphere at Parker-Bennett school.

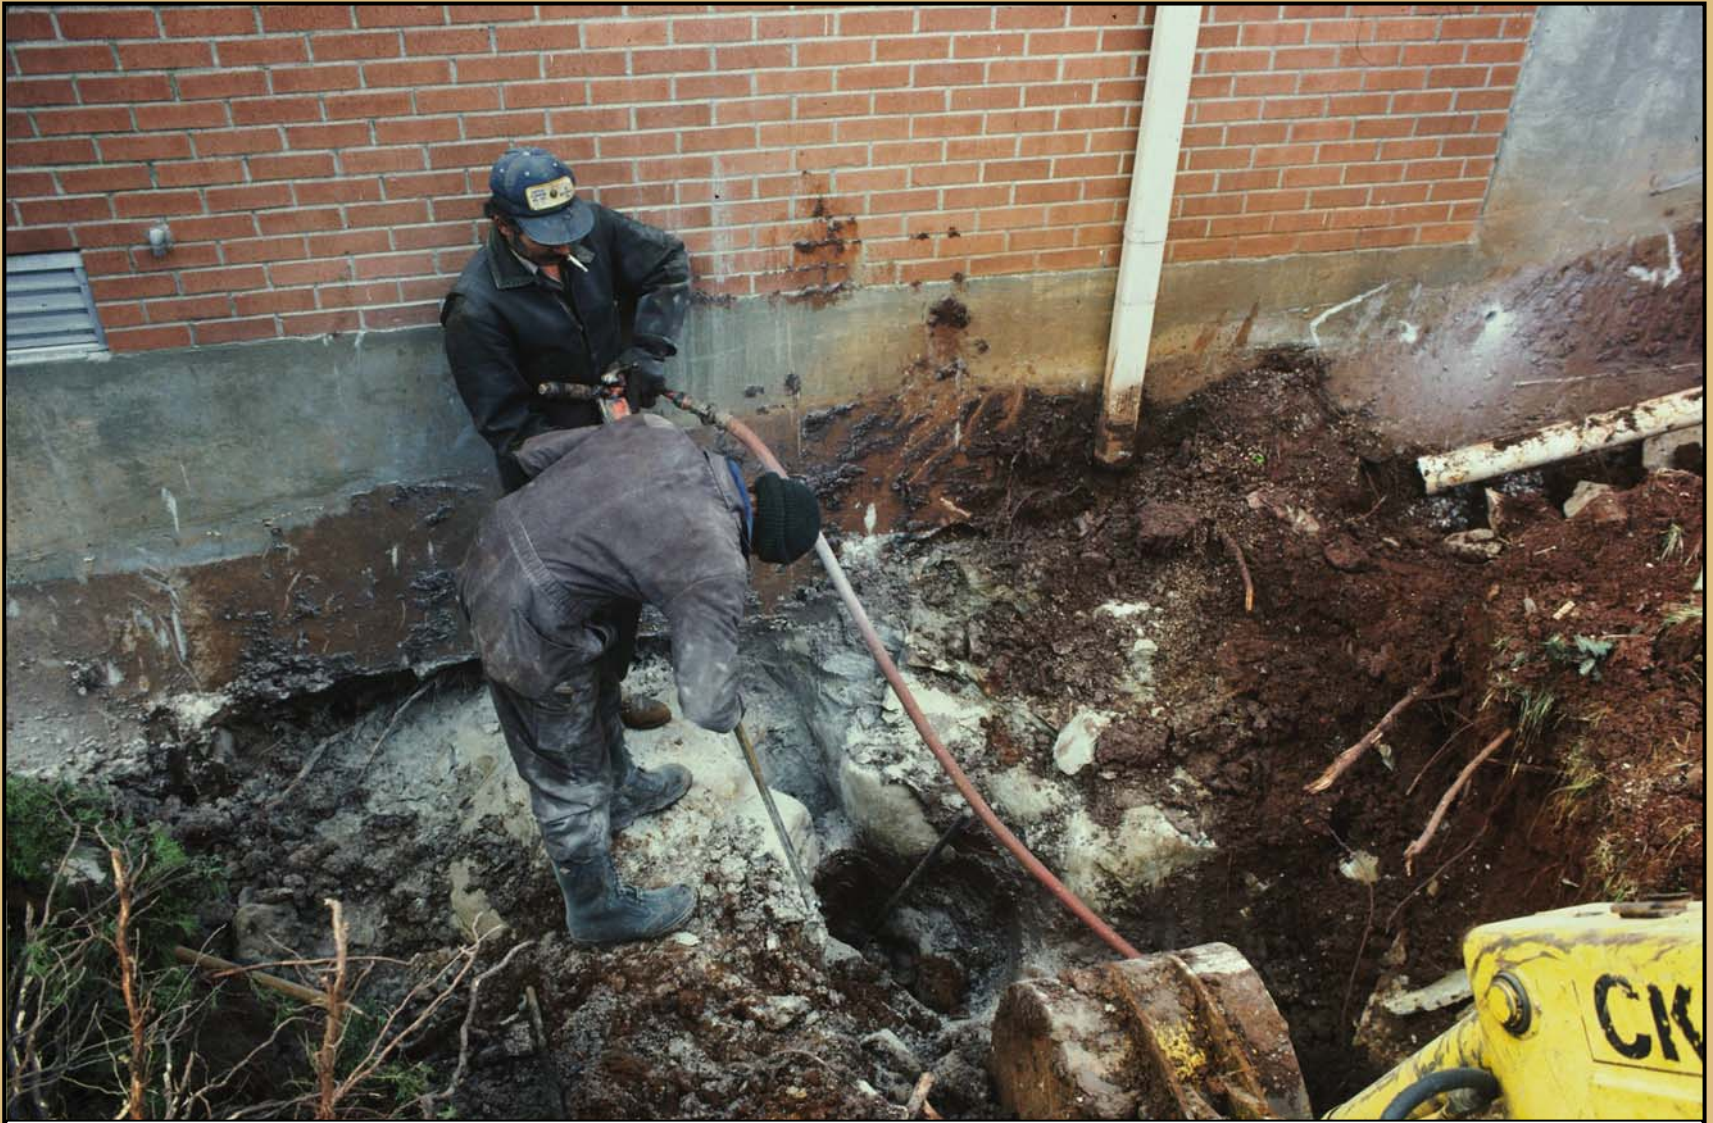
Excavation to expose crevice at Dishman-McGinnis Elementary School in Bowling Green, Kentucky.

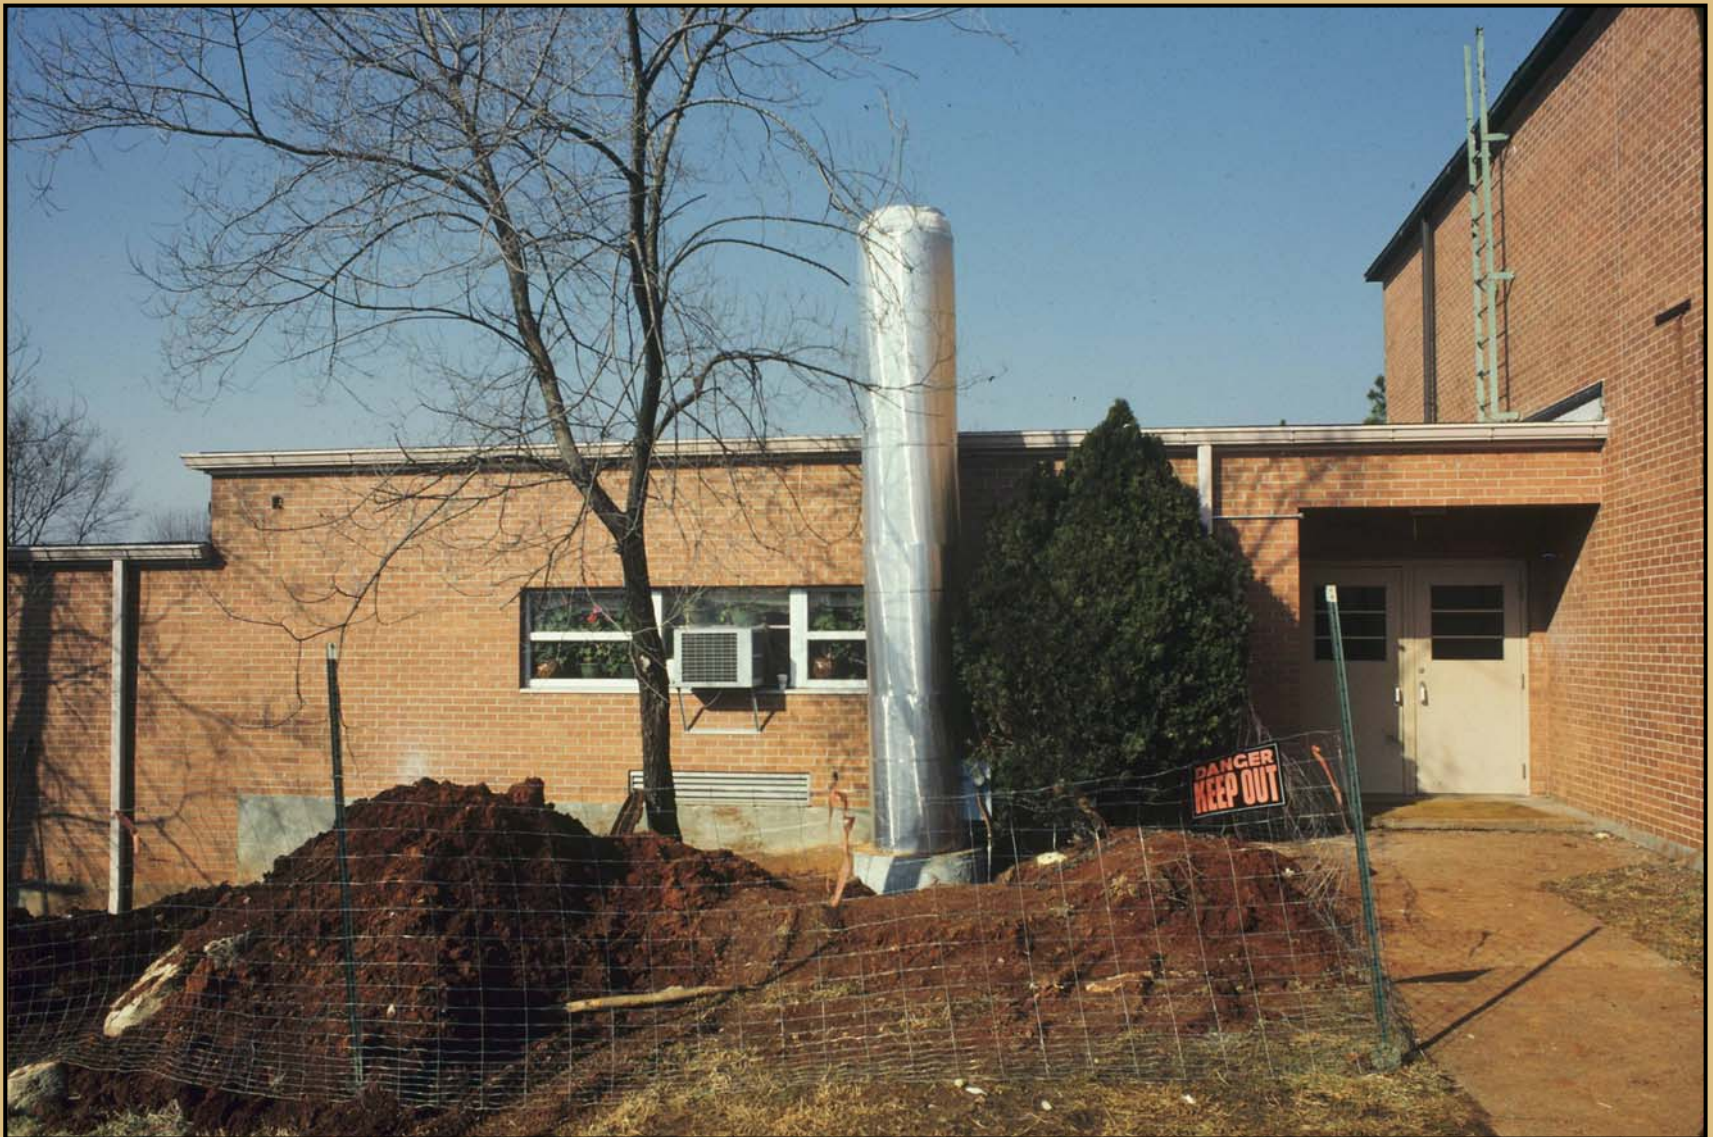
Pipe and fan to vent toxic and explosive vapors into the atmosphere at Dishman-McGinnis Elementary School.

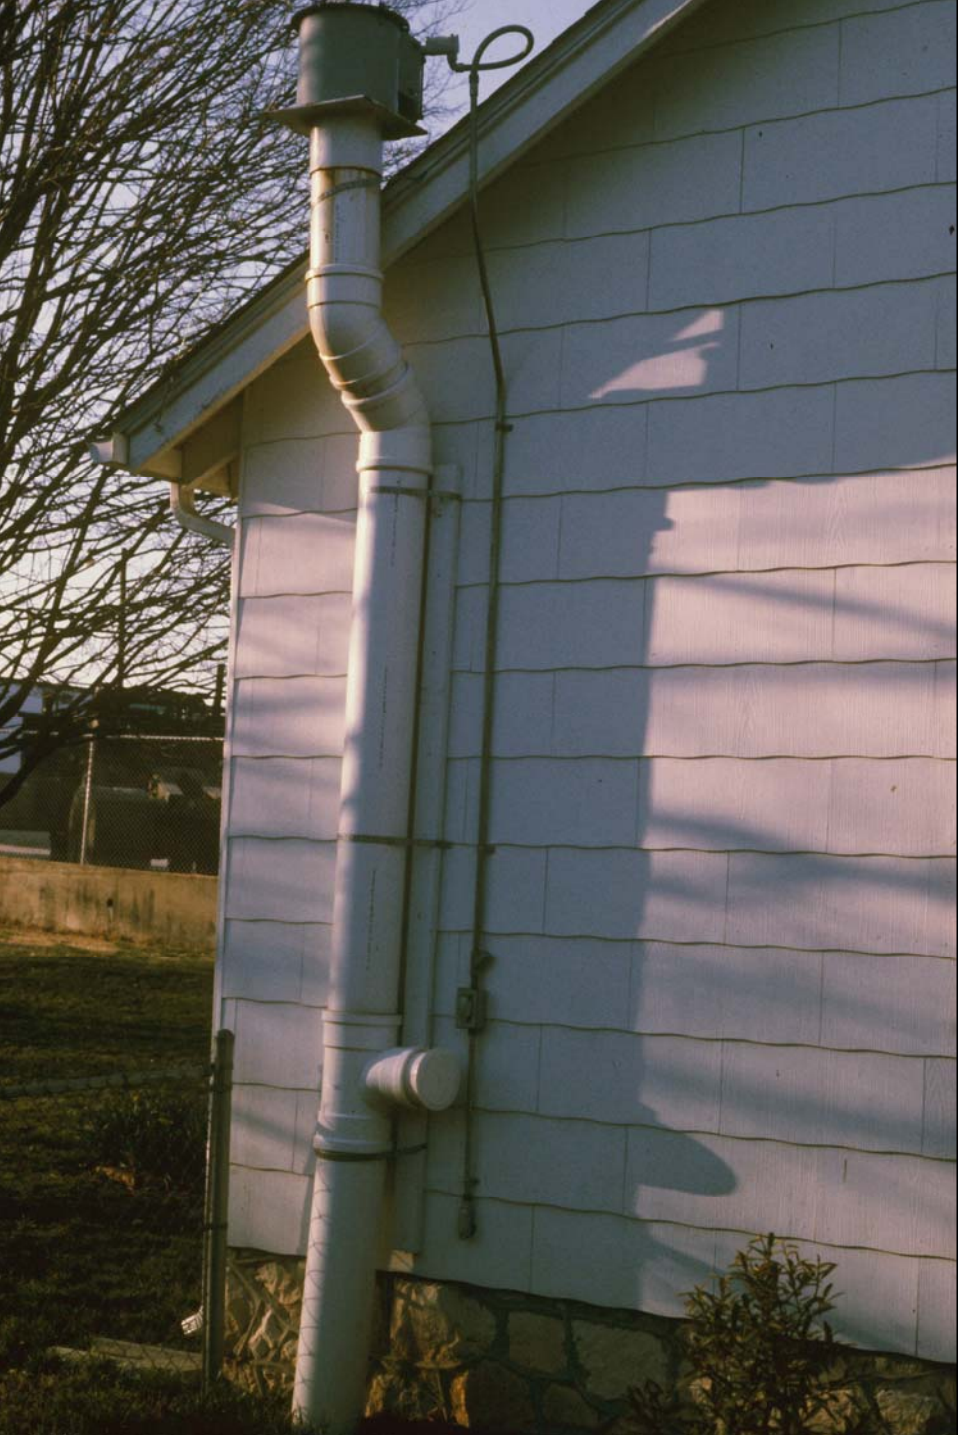
Ventilation pipe and fan at George Diamond's home is typical of ventilation systems at other houses.

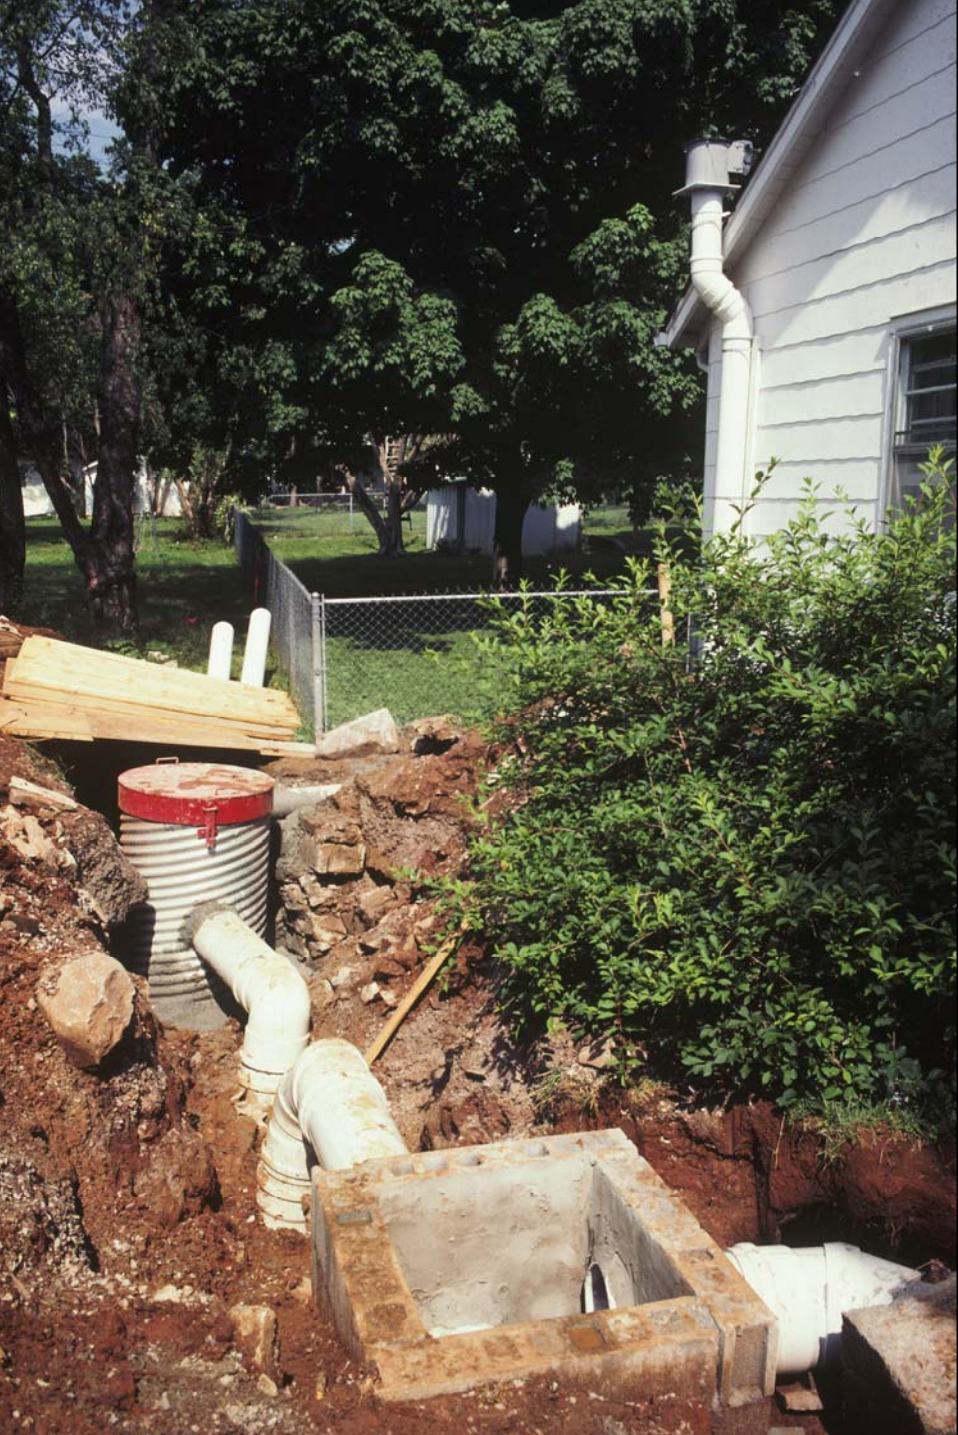
Excavation by the Center for Cave and Karst Studies into storm water drainage well leading into Napier Cave. Notice trap for storm water in foreground and vapor ventilation fan adjacent to house in background.

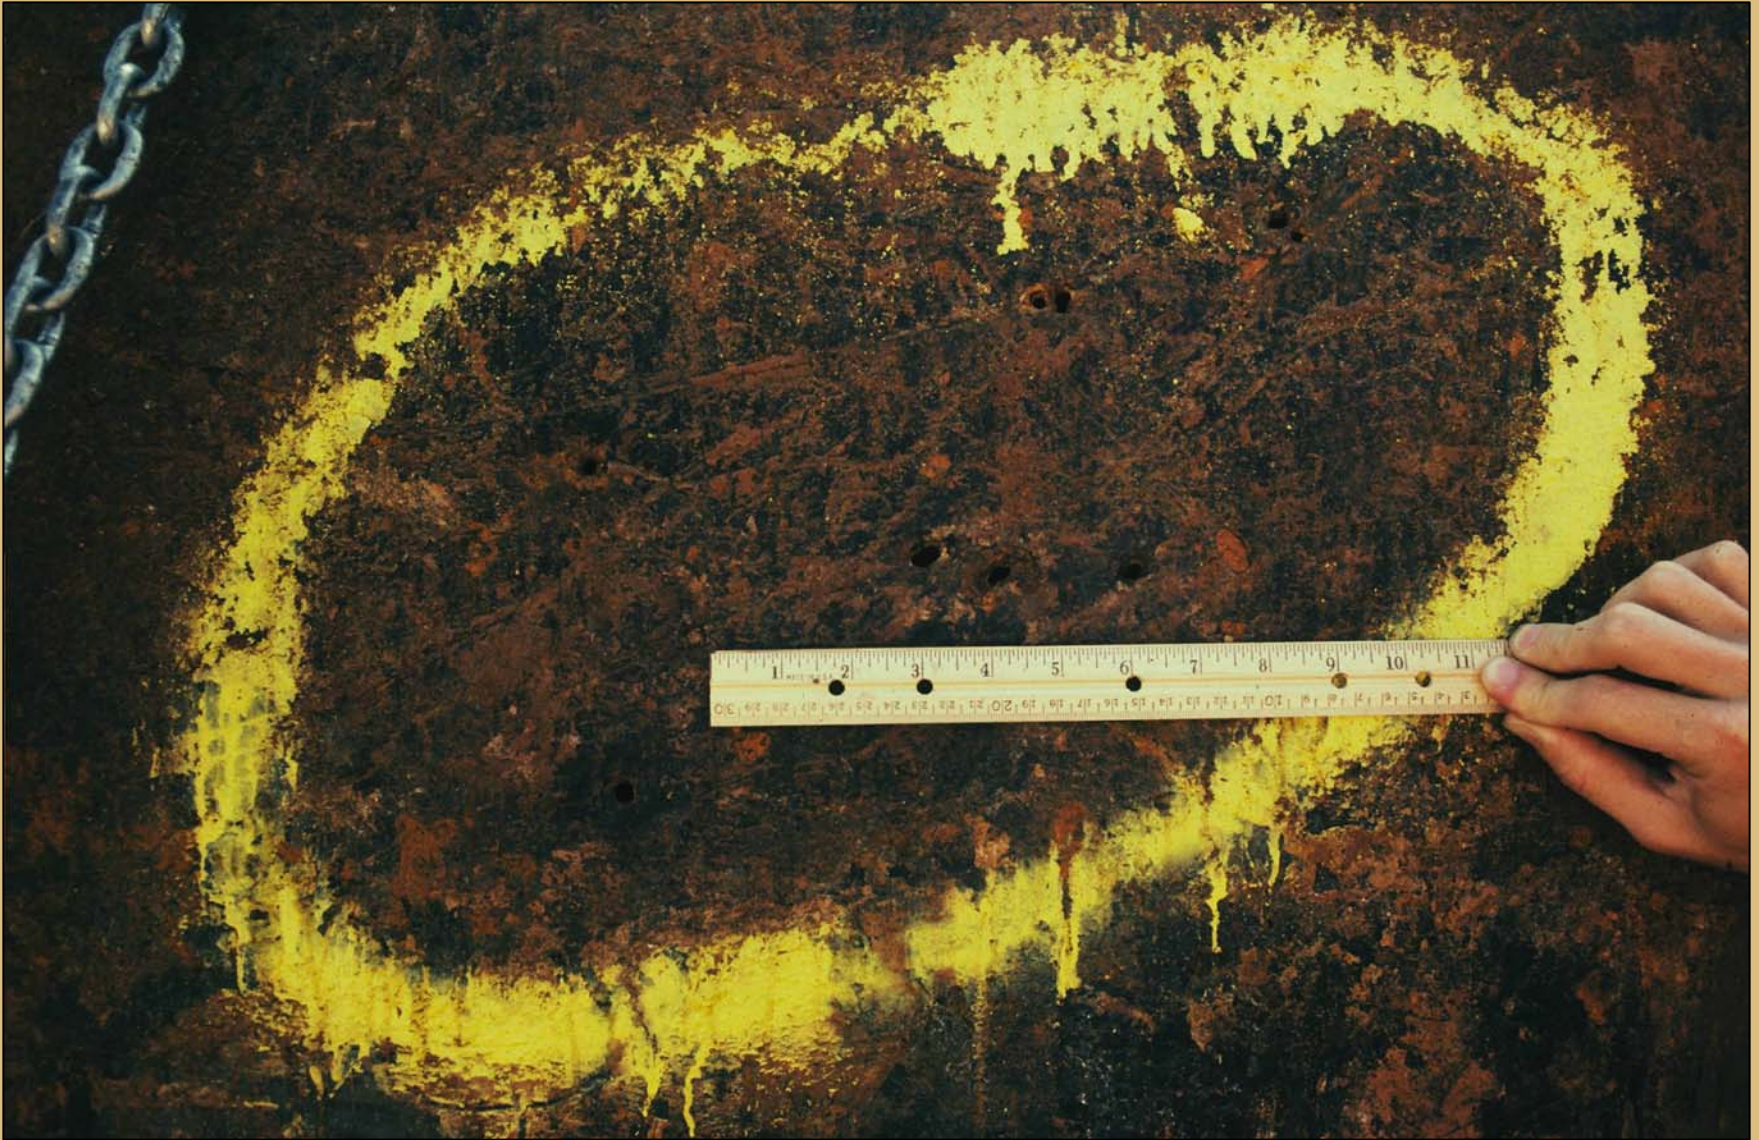
Although the owners insisted that this tank was not leaking, upon excavation, 13 holes were discovered along the side of the tank.

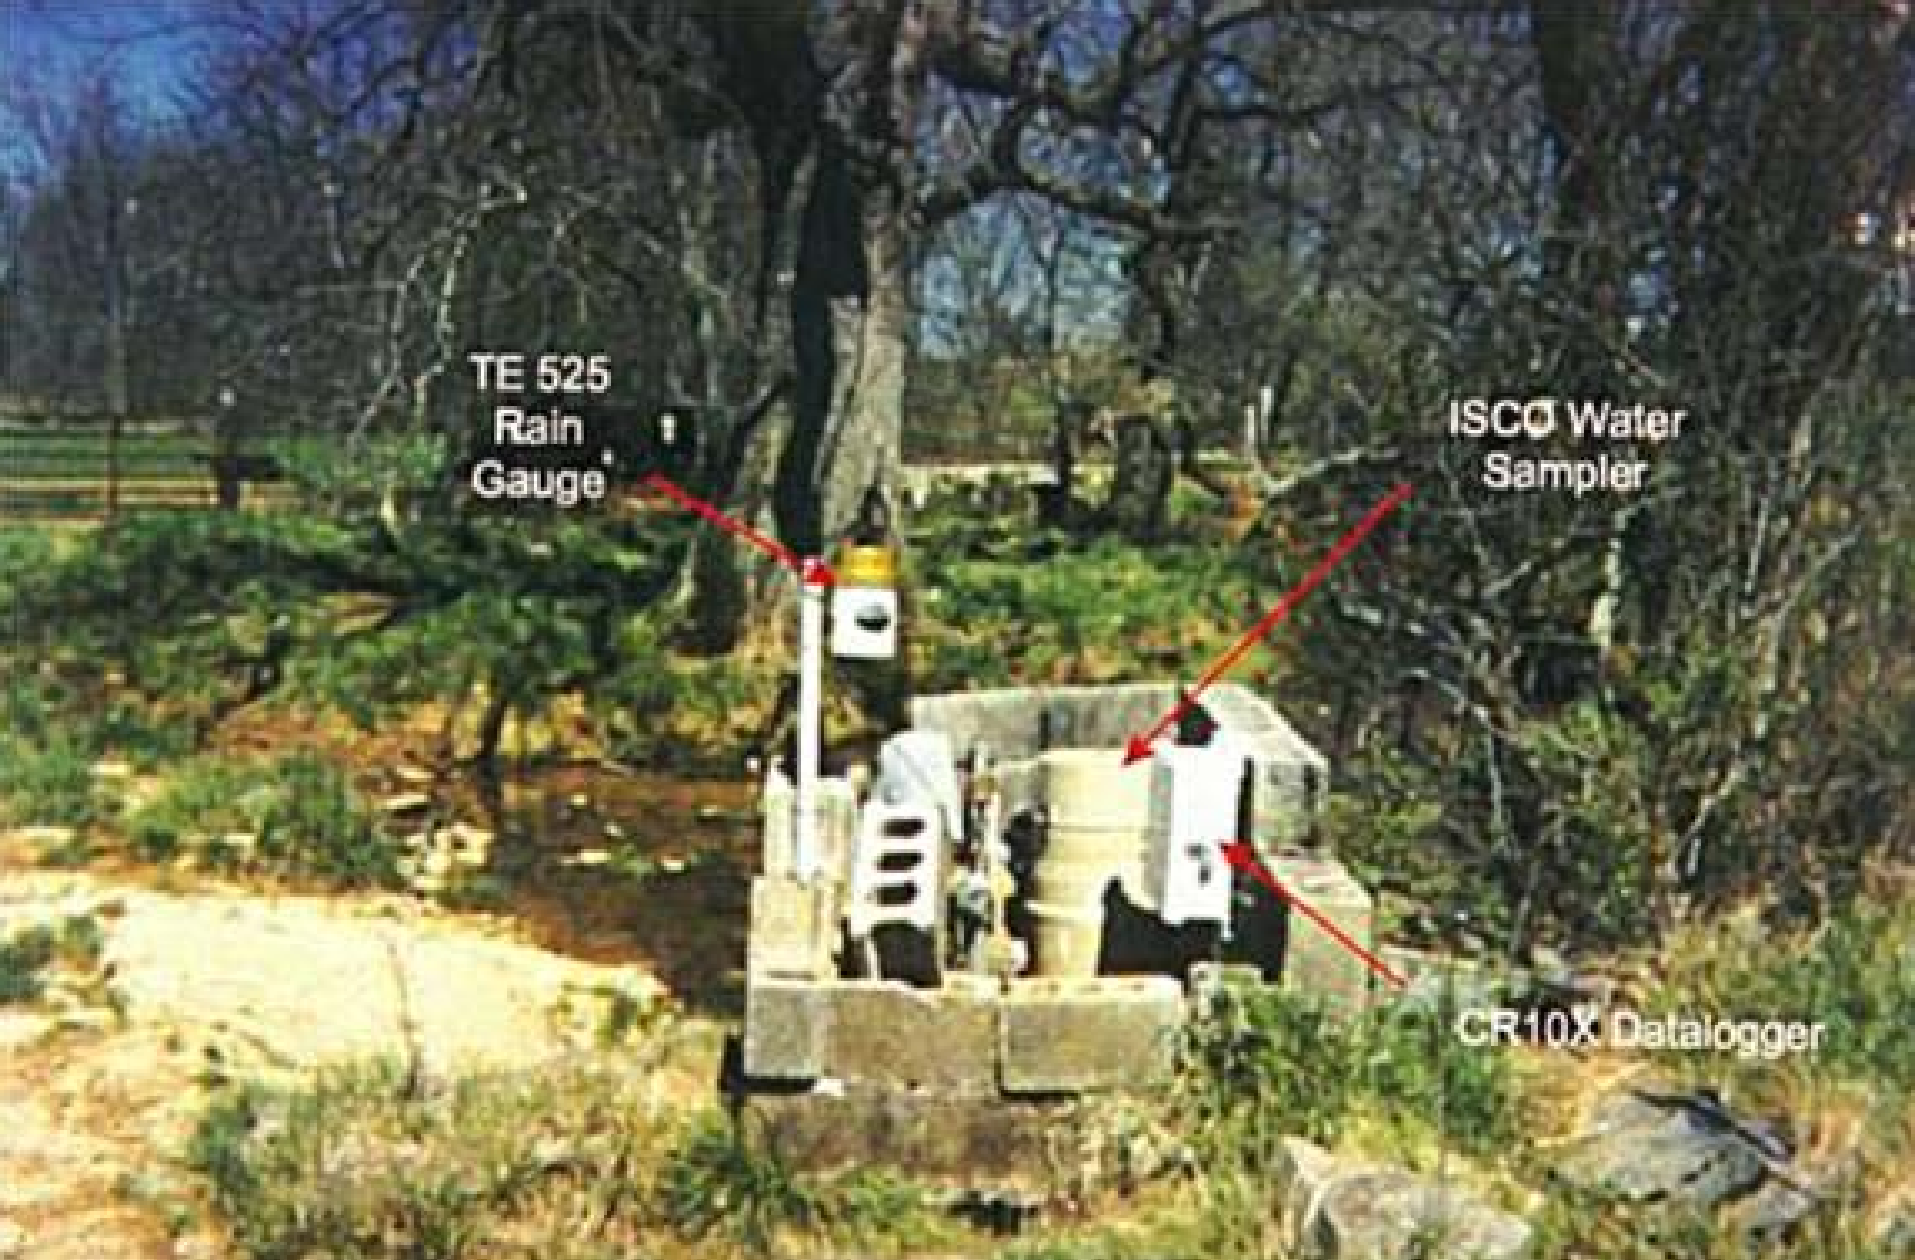
TE 525  
Rain  
Gauge

ISCO Water  
Sampler

CR10X Datalogger

**Instrumentation at Wells Spring**

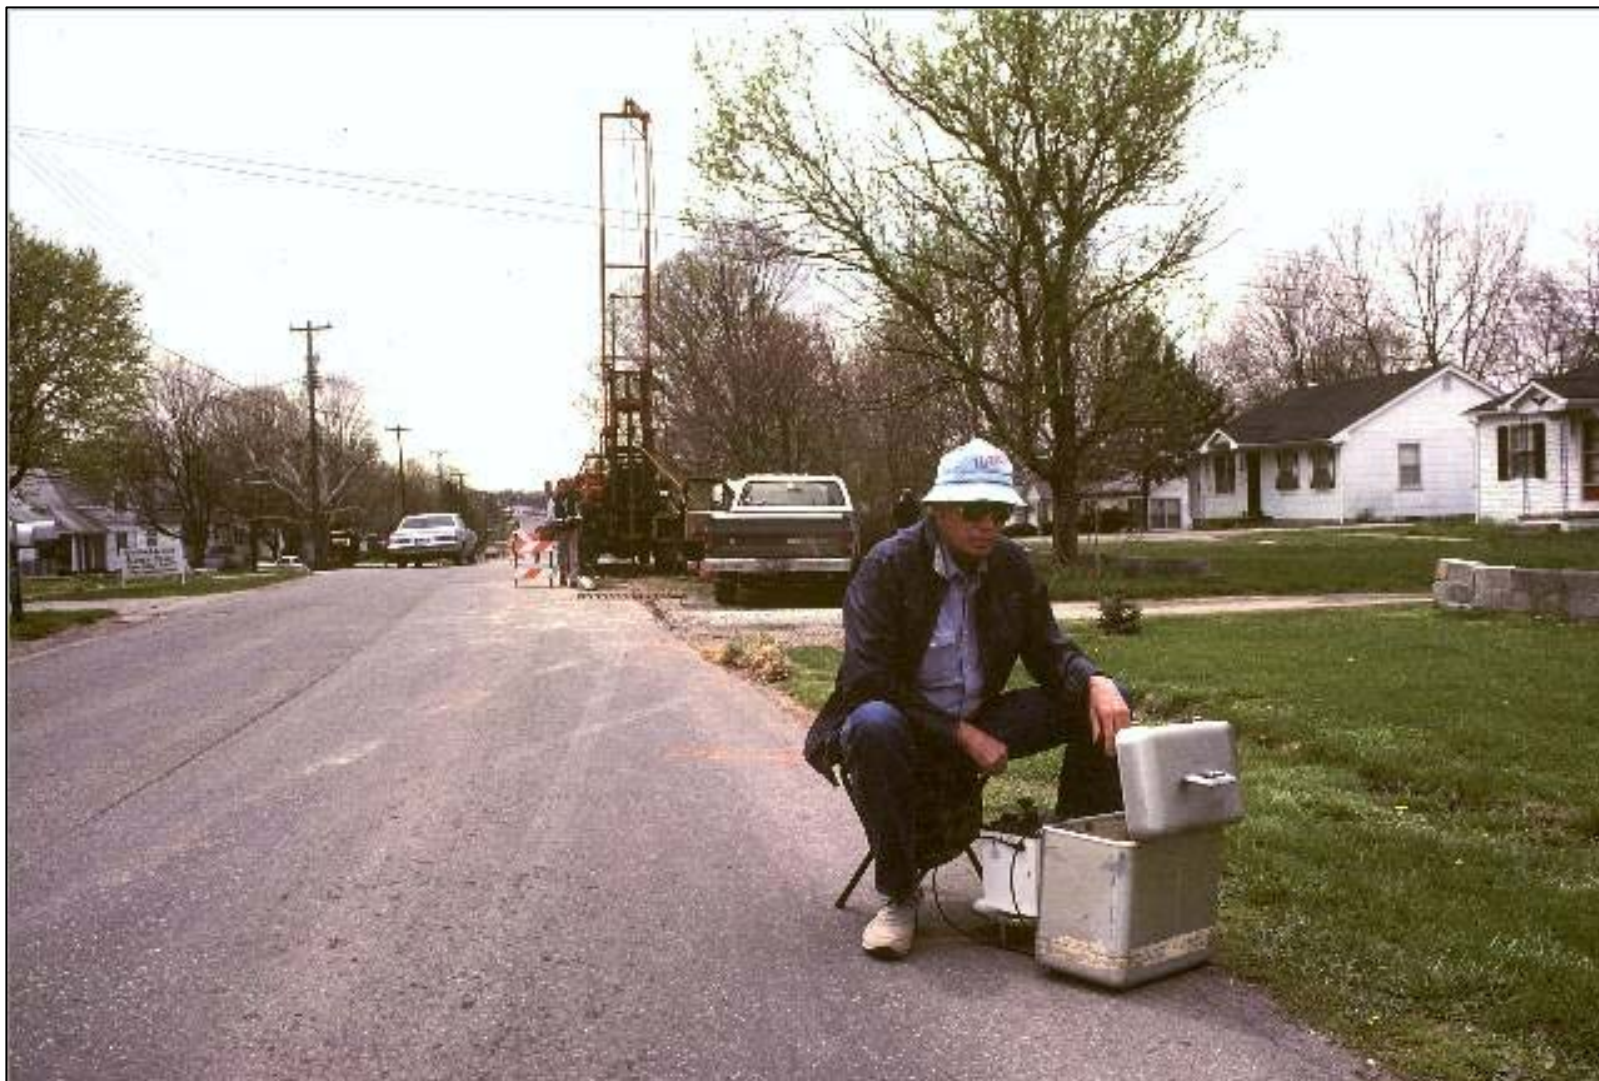
**First attempt to explore for unknown caves. LaCoste and Romberg Model D microgravity meter.**

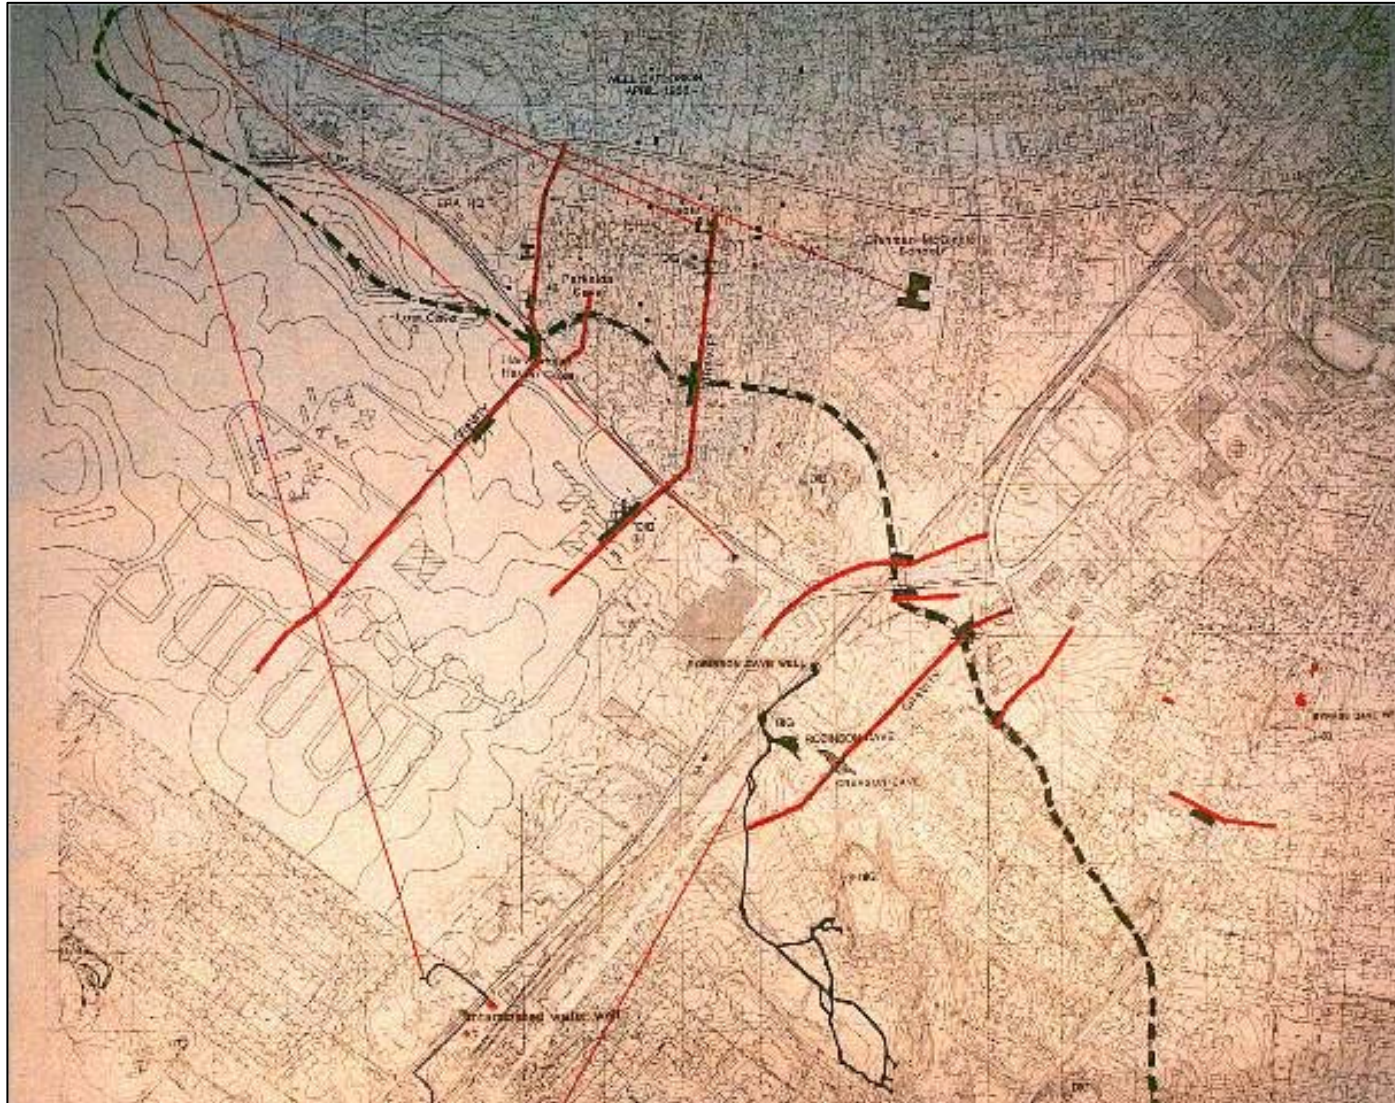
Mapped portions of Lost River Cave and present-day and ancient routes as determined by microgravity (Crawford, 1986). Notice that some of the low-gravity anomalies are over previously mapped portions of Lost River Cave. Most of the other low-gravity anomalies have been confirmed by exploratory borings into the low-gravity anomaly and along both sides of the anomaly. Dye tracer tests were performed to confirm that the wells drilled into the low-gravity anomalies were in fact the Lost River.
